Performance of the Acrylife Roof Vent

Report: IBHS-12XX01
August 31, 2012

Prepared for: Acrylife
1165 Stafford Umberger Dr.
Wytheville, Virginia
USA

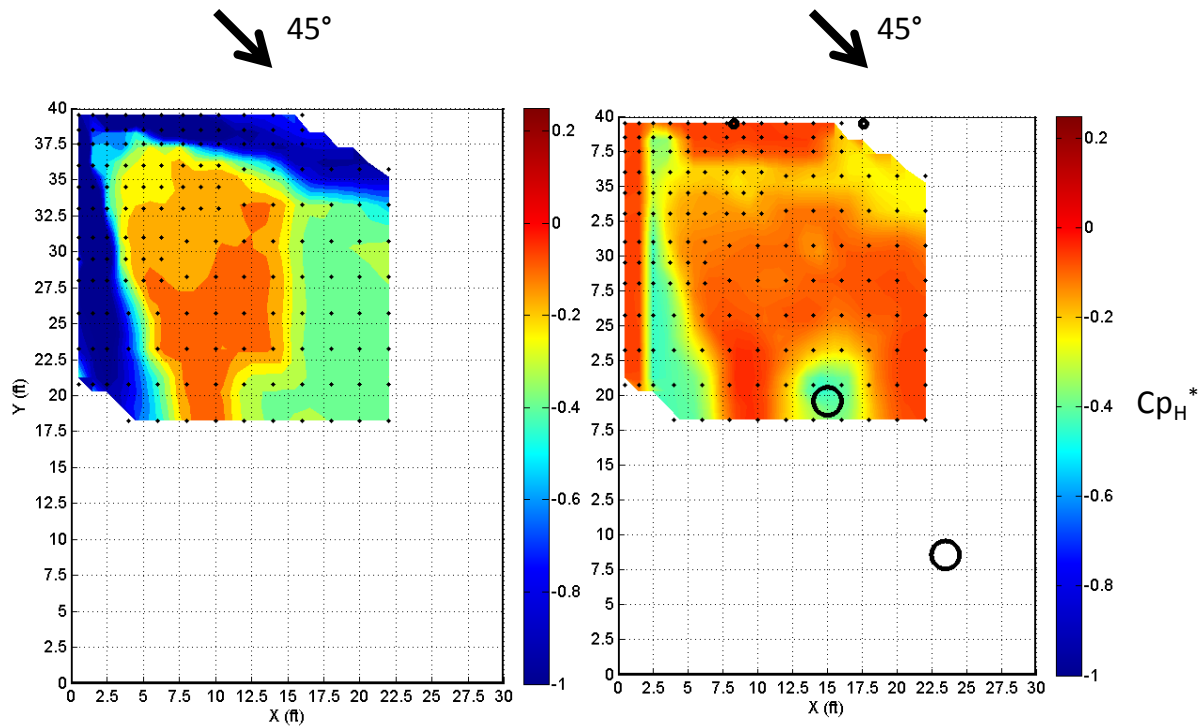
*Pressure coefficients referenced to a 900 second roof height wind speed.
 As presented these coefficients cannot be compared directly to ASCE7

Figure 3 Surface pressures on the roof deck of the building at 45 degrees (left) test #1 with no membrane (right) test #5 with the re-sealed membrane with 2 active roof vents and 2 active parapet vents as shown by the black circles. The colors in both left and right figures are presented in the same scale.

Figure 3 presents the mean surface pressure results from test #1 (left) and test #5 (right) at a wind angle of 45 degrees. Similar to Figure 2 the surface pressures near the edges of the building in Figure 3 (right) are erroneous due to the sealing of the membrane to the roof deck. As a result it is difficult to determine if the mean surface pressures with and without the membrane follow the same general pattern as they did at a wind angle of 0 degrees (Figure 1), although it is very likely that they do. However, what is notable is that the pattern of the surface pressures in close proximity to the roof vent in the center of the roof ($X \sim 15$ ft, $Y \sim 20$ ft) appears to be affected by the presence of the roof vent. However, the area affected appears to be small since the only deck surface pressures showing any effects are located in a 2.5 ft radius from the center of the roof vent. Moreover, this effect is localized to a region of the roof that has relative low wind loads compared to the high wind loading present along the edges of the roof. Since no effect at all was observed at a wind angle of 0 degrees it appears that the placement of the vent is critical and varies based on wind angle. Based on data currently available, the sensitivity of results to the vents location coupled with the limited area of influence of the vent indicate that widespread mitigation of the wind load on the roof membrane particularly in the highest loaded edge regions of the roof may not be feasible.

It should be noted that pressures presented in the report are time averaged quantities. Due to the fact that the wind loads on the roof vary significantly in both space and time and since pressures on the exterior surface of the membrane (Figures 1 (left) and 3 (left)) and between the membrane and the roof deck were not obtained simultaneously, the correlation between the pressures above and below the membrane cannot be determined. Consequently, the net loads applied to the membrane cannot be determined from the current test results, as the pressures both above and below the membrane may not be correlated (i.e. a high suction on the exterior of the membrane may coincide with a low suction between the membrane and the roof).
